5. Existing Conditions

UNIVERSITY OF ALASKA FAIRBANKS MASTER PLAN

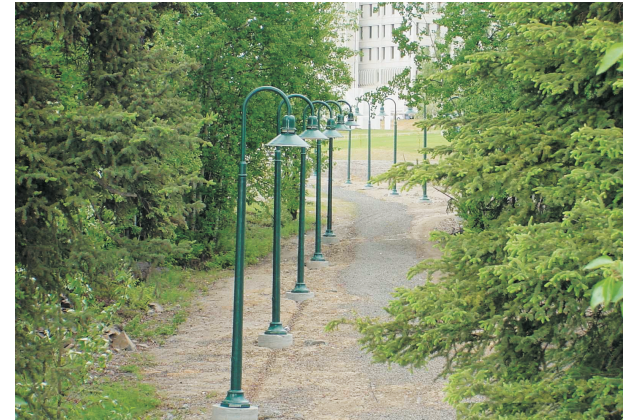
Path lighting on campus

Current campus lighting standards were set in 1994 for roadways, walkways, parking lots and stairways as a result of an evaluation of campus lighting levels prepared by the university. However, no standards exist for pole heights and fixture types. Lighting fixtures tend to be vehicular in scale and utilitarian in design, even in pedestrian areas such as the Fountain of Flags and Constitution Park. An exception is the row of small-scale fixtures along the path-

way leading from Fairbanks Street just north of the railroad tracks, which together with planting creates a pleasant pedestrian experience.
