Under the Ice: Winter Conditions of Happy Creek Following Restoration

Restoration for Salmon

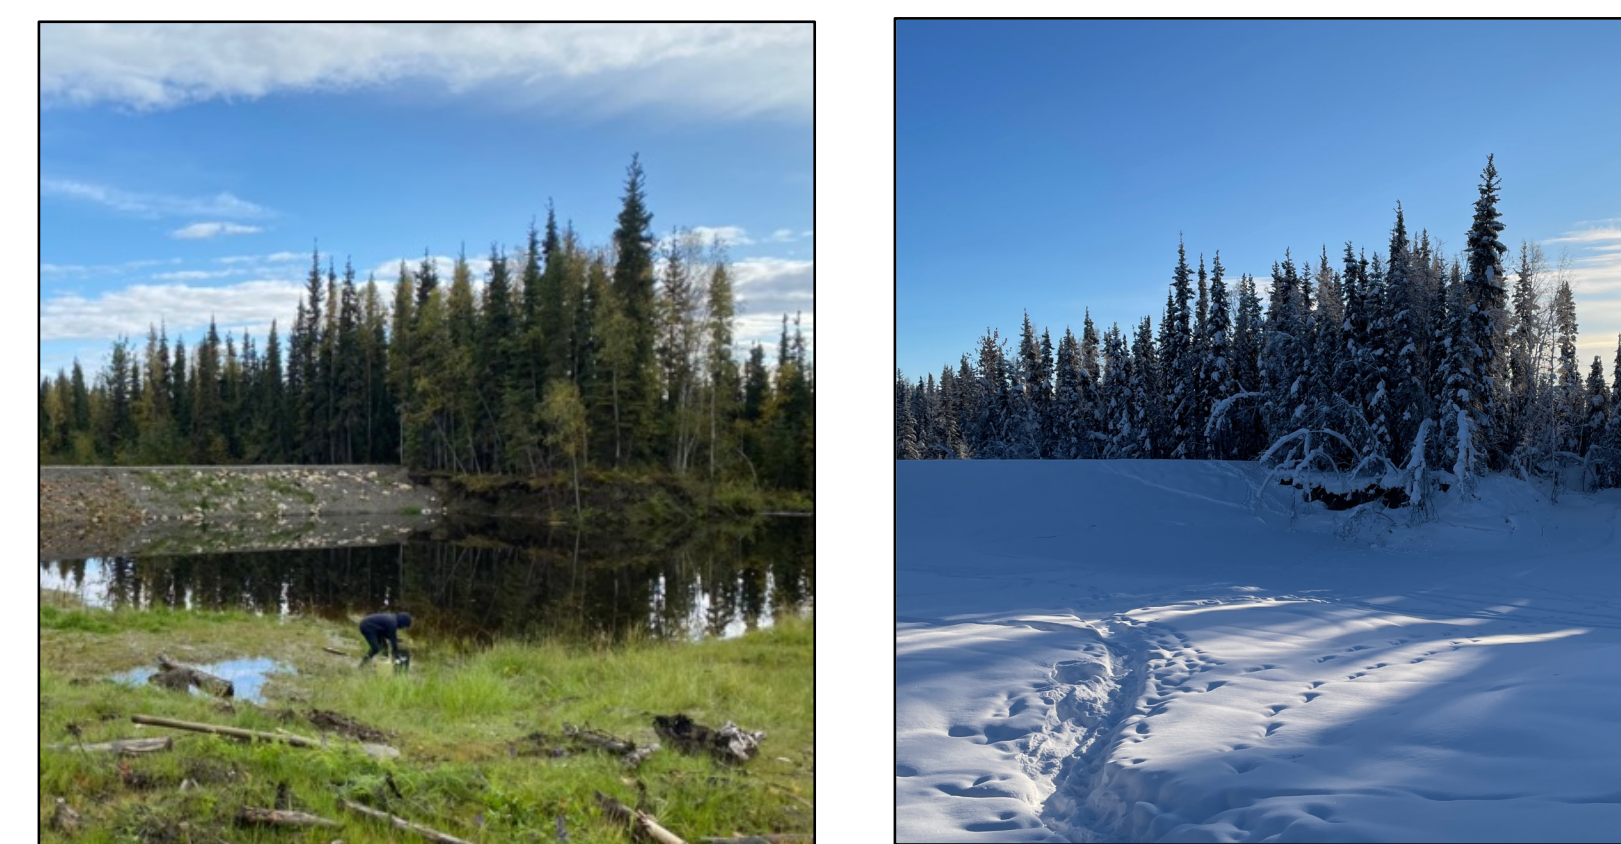
(Above) Figure 2: Photographs from summer 2023 and winter 2024 overlooking Happy Creek site #1. Due to the restoration, this site was submerged beneath several feet of water, resulting in lots of plant matter beneath the surface.

Samples and data were collected in February 2024 from two sites where Happy Creek intersects the restoration. Site #1 is where the smell was first detected, in the pond seen in figure 2, and site #2 is over Happy Creek.

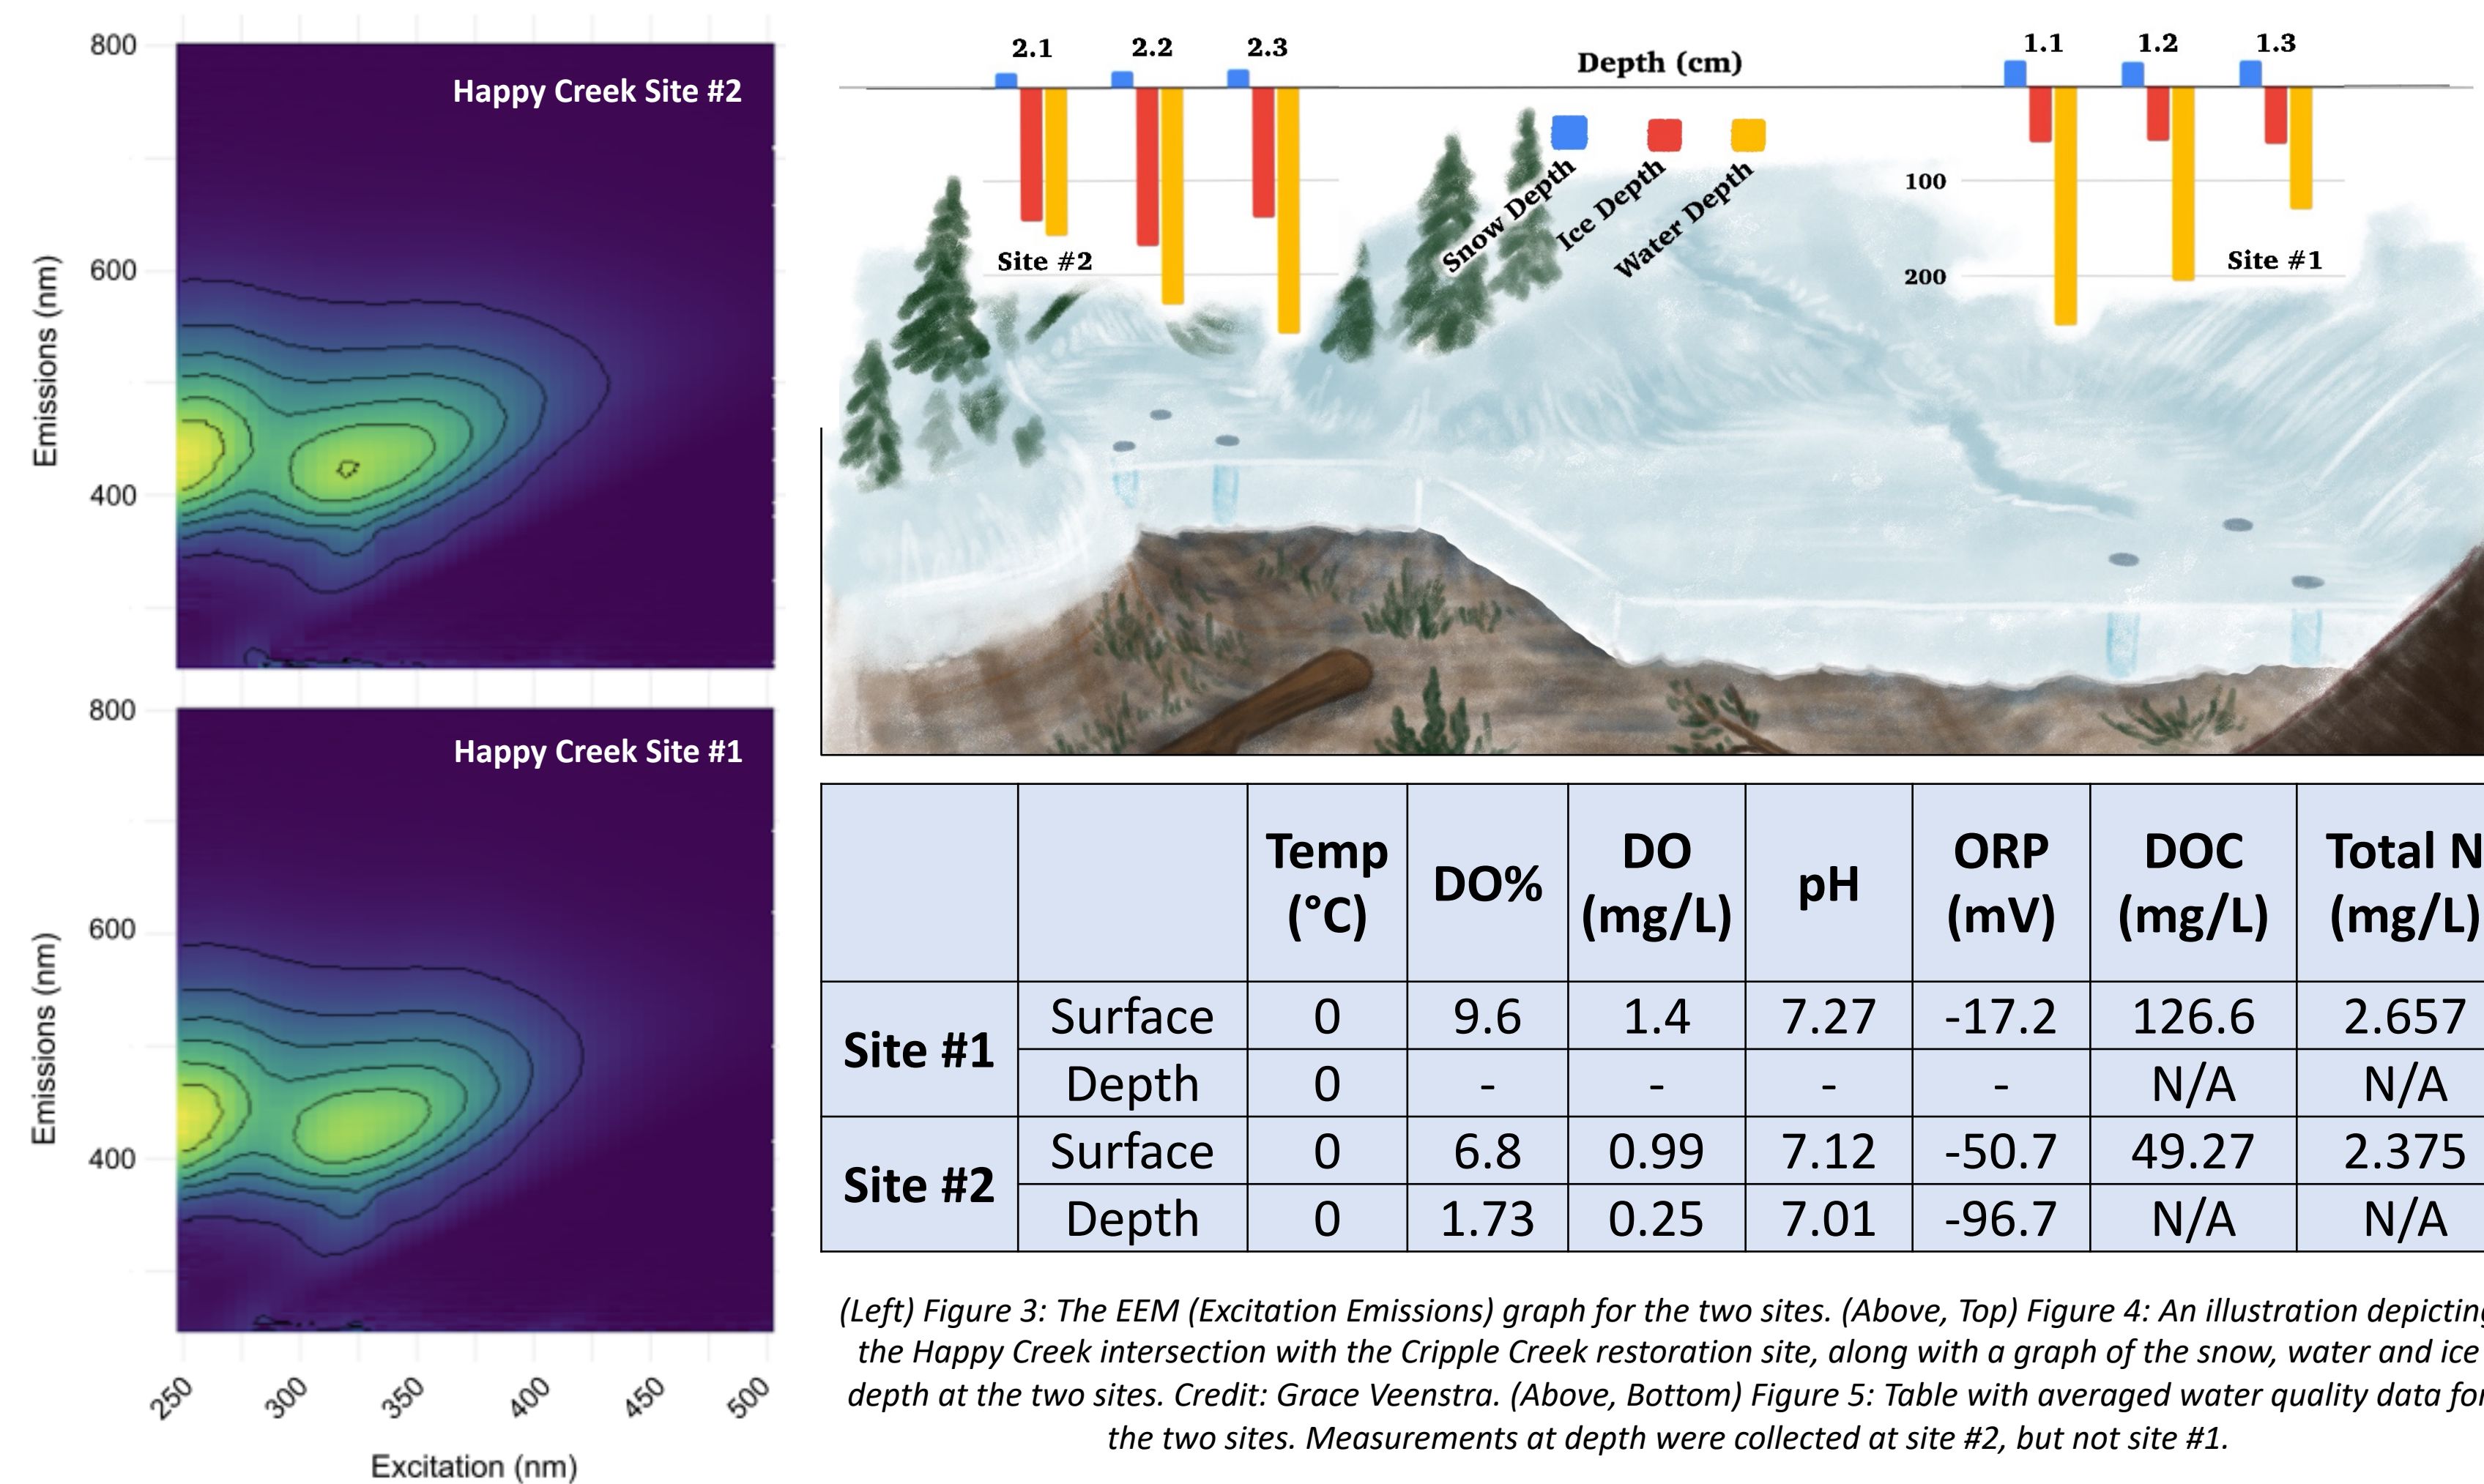
(Left) Figure 3: The EEM (Excitation Emissions) graph for the two sites. (Above, Top) Figure 4: An illustration depicting the Happy Creek intersection with the Cripple Creek restoration site, along with a graph of the snow, water and ice depth at the two sites. Credit: Grace Veenstra. (Above, Bottom) Figure 5: Table with averaged water quality data for the two sites. Measurements at depth were collected at site #2, but not site #1.

From our EEM data, we can conclude that the dissolved organic carbon (DOC) present is primarily sourced from terrestrial plants or soil organic matter. Furthermore, there is over twice as much DOC at site #1 than in site #2. This could be due to (a) more water flow beneath the ice at site #2 or (b) more plant carbon by volume at site #1.

Even close to the surface, conditions beneath the ice were hypoxic, with low levels of dissolved oxygen (DO). The pH is slightly more acidic, but still within typical bounds for freshwater. Based on our oxidation-reduction potential (ORP) values, it's probable that sulfide formation could be occurring (H₂S formation occurs from -50 to -250 mV).

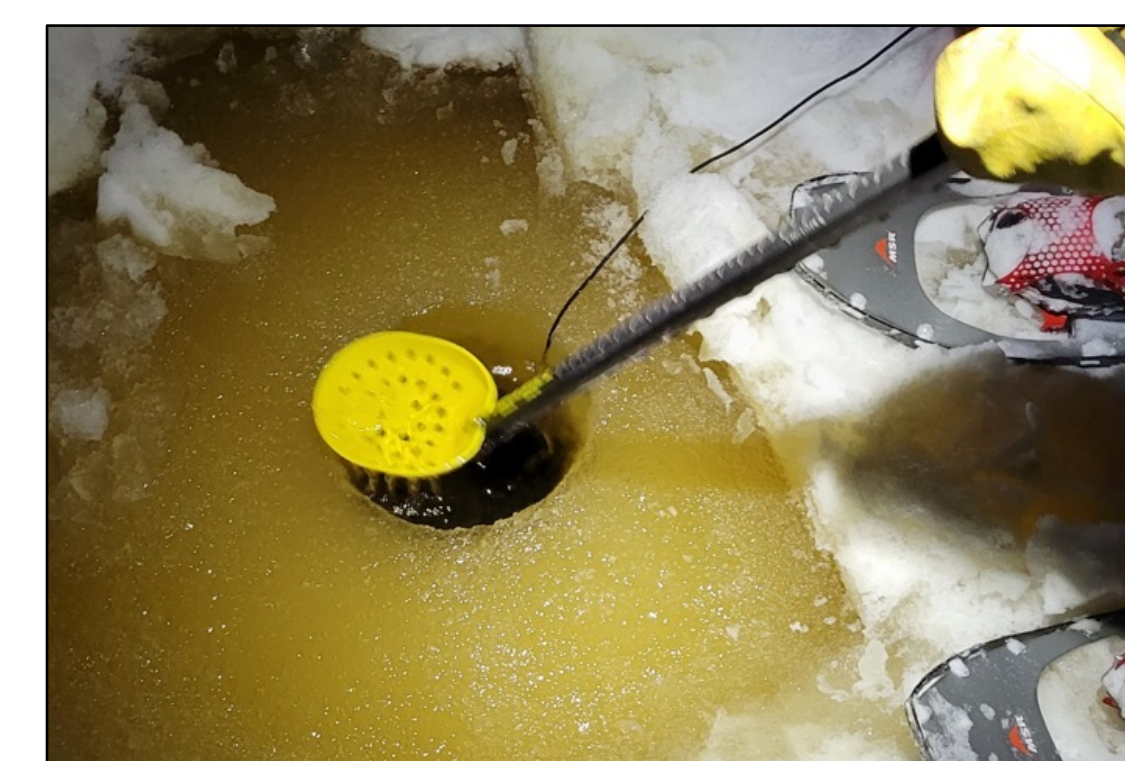
Figure 6: A picture of what Nate and Christi Buffington encountered in December 2023 after drilling through the ice at Happy Creek.

In December 2023, researchers measuring the ice where Happy Creek intersects the Cripple Creek restoration site (Fig. 1) reported a sulfurous smell coming from the water and saw discoloration of the ice (Fig. 6). This promoted my preliminary look into the water conditions below the ice.
