Dendrochronology and the Mile 11 Landslide in Wrangell, Alaska

Introduction

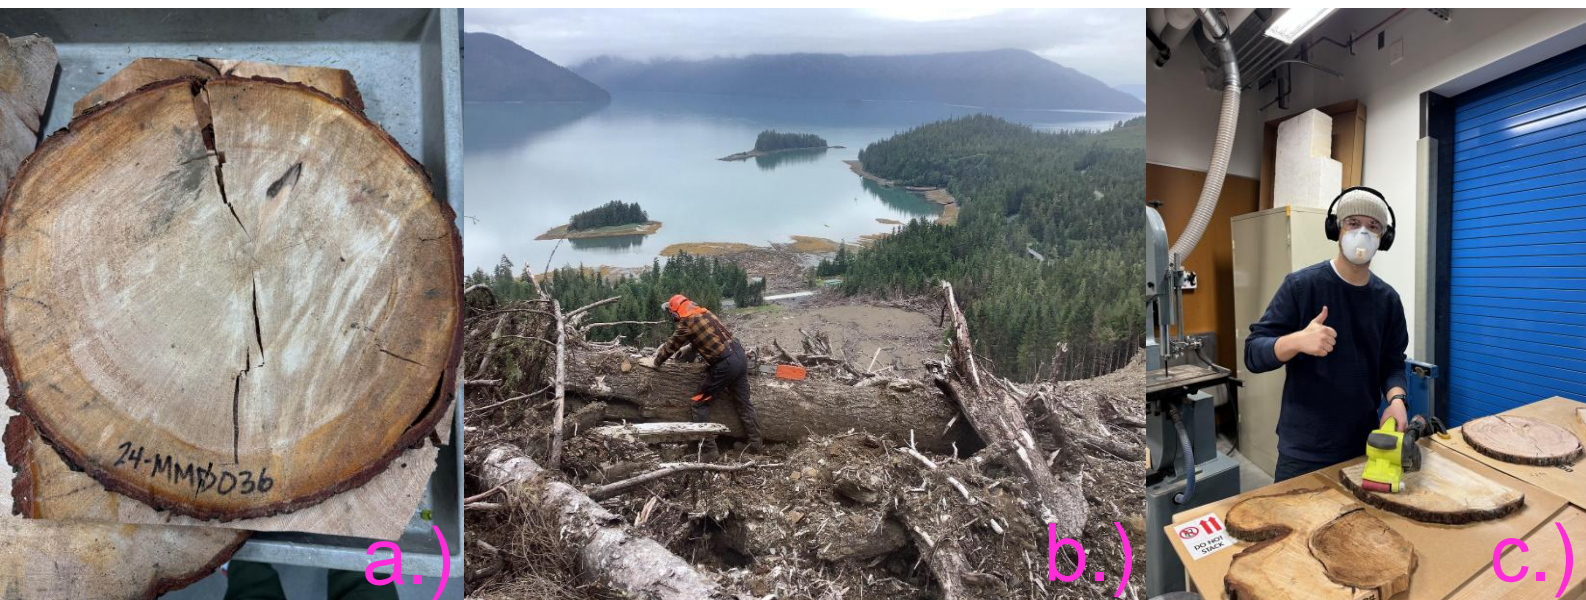
Figure 1. (a) An unsanded tree cookie. (b) A sawyer preparing to cut a cookie. (c) Sanding the tree cookies. Photo credits: (a) J. Fields, (b) M. Darrow, (c) J. Davis

1. Cut slabs (cookies) off downed Western Hemlock trees in Wrangell using a chainsaw.
2. Dry samples.
3. Sand rings using 50, 120, 150, 220, and 400 grit sandpaper with a belt sander and a palm sander.
4. Scan samples using a high resolution scanner.
5. Count tree cookies rings by hand and note any anomalies.
